## **INSTALLATION INSTRUCTIONS**

GRILL/ BRUSH GUARD 4064  
2004-05 CHEVROLET COLORADO/GMC CANYON 2/4WD

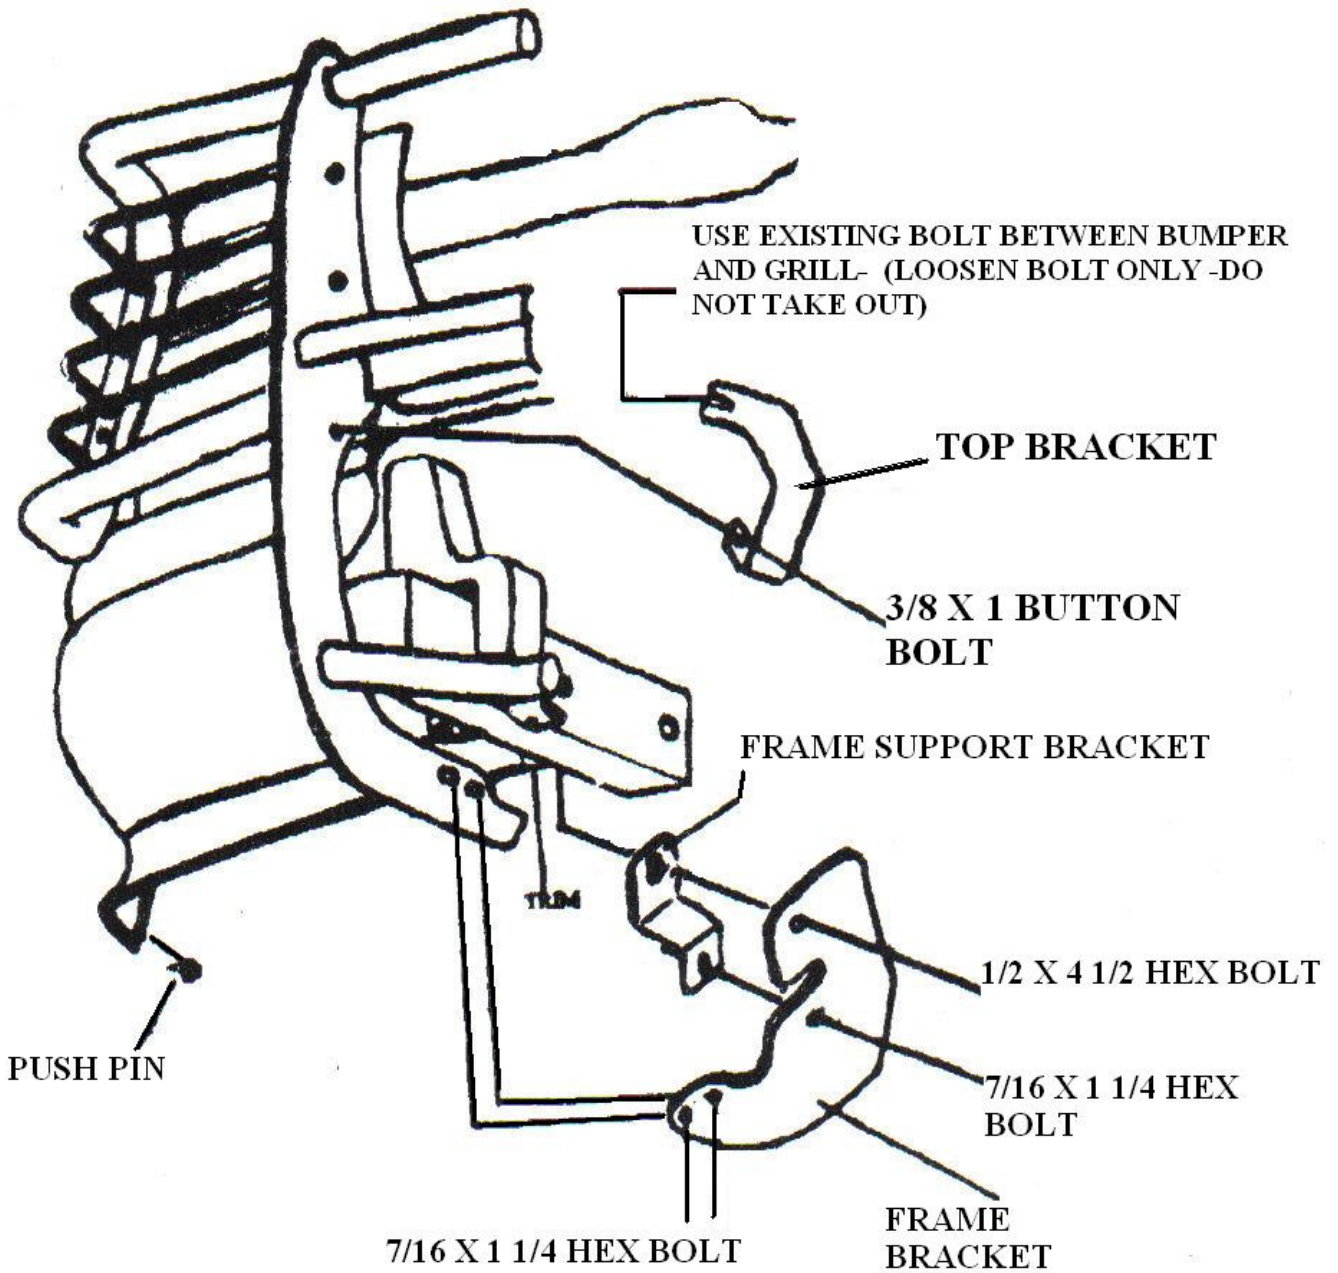
# PASSENGER SIDE SHOWN

1. Remove lower valance (plastic) by removing two push pins from side of the lower bumper. Pry the tabs out from the valance and remove.
2. Position passenger side frame bracket to the inside of the frame rail and the frame support bracket to the outer side of the frame rail (longer side to the frame rail) and secure using 1/2 x 4 1/2 fasteners and 7/16 x 1 1/4 fasteners (shown in illustration). Hand tighten and repeat driver side.

3. Loosen the factory bolts 1/4" turn (do not take out bolt) directly between bumper and grill. The bolt pattern on the top support will be positioned in manner shown on illustration (passenger side shown) attach using existing hex bolts.

4. Line up the 2 holes on the lower portion of the Front Bar with the 2 holes of the Frame Mount Brackets (outer edge) and attach using 7/16" x 1 1/4" hex bolts, 7/16" flat washers, and 7/16" hex lock nuts for each side. Hand tighten.

5. Proceed to attach top support brackets to the inner edge of front bumper up rights using the 3/8 x 1 button bolts, and hardware.
6. Align front bar assembly with front of the vehicle and secure all fasteners.
