## INSTRUCTIONS

### MOUNT KIT 224010 (2000-04 CHEVROLET TAHOE/GM YUKON 1500)

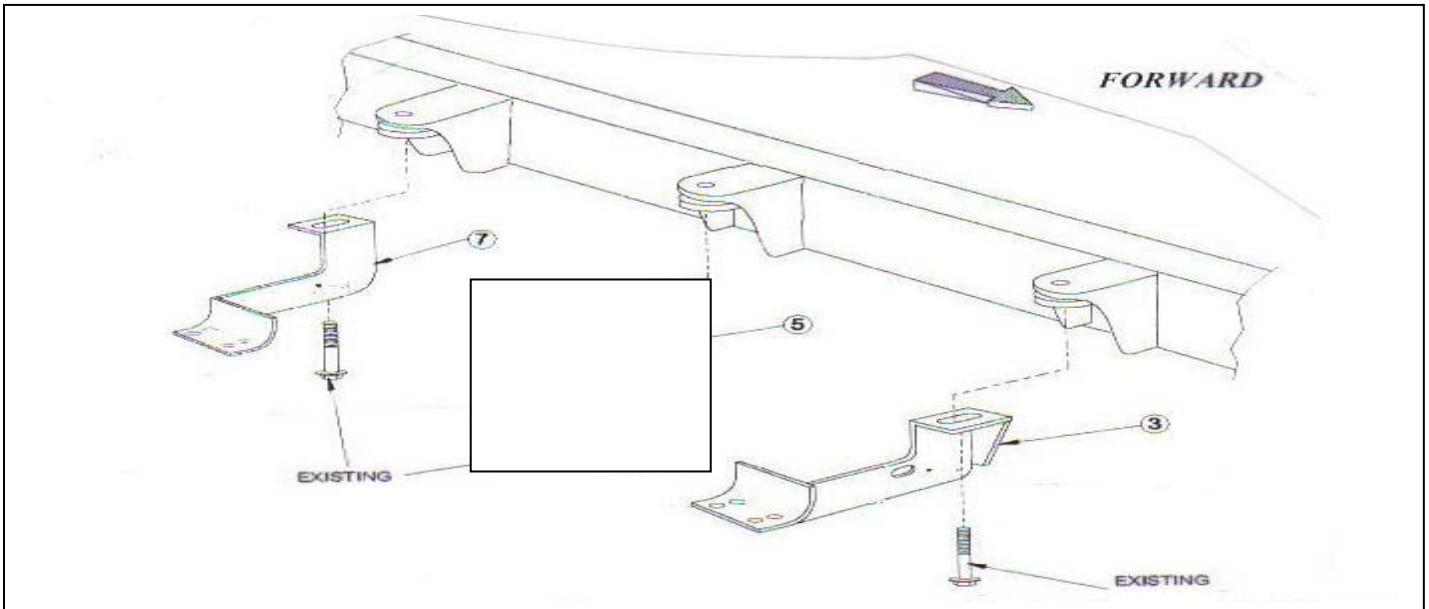
FIGURE 1

**STEP 3** INSTALL BRACKETS AS SHOWN. HAND TIGHTEN (SEE FIGURE 1).

**STEP 4** LINE BRACKET HOLES WITH THE THOSE OF THE OVAL TUBE. ASSEMBLE 1/4" HARDWARE.

**STEP 5** MAKE SURE STEP BAR AND BRACKETS ARE PROPERLY ALIGNED. TIGHTEN AND TORQUE 5/16" HARDWARE TO 19 FT-LBS. AND 1/4" HARDWARE TO 9 FT-LBS.
